**Figure 1. Survey Location Map – Aptos Creek Watershed**

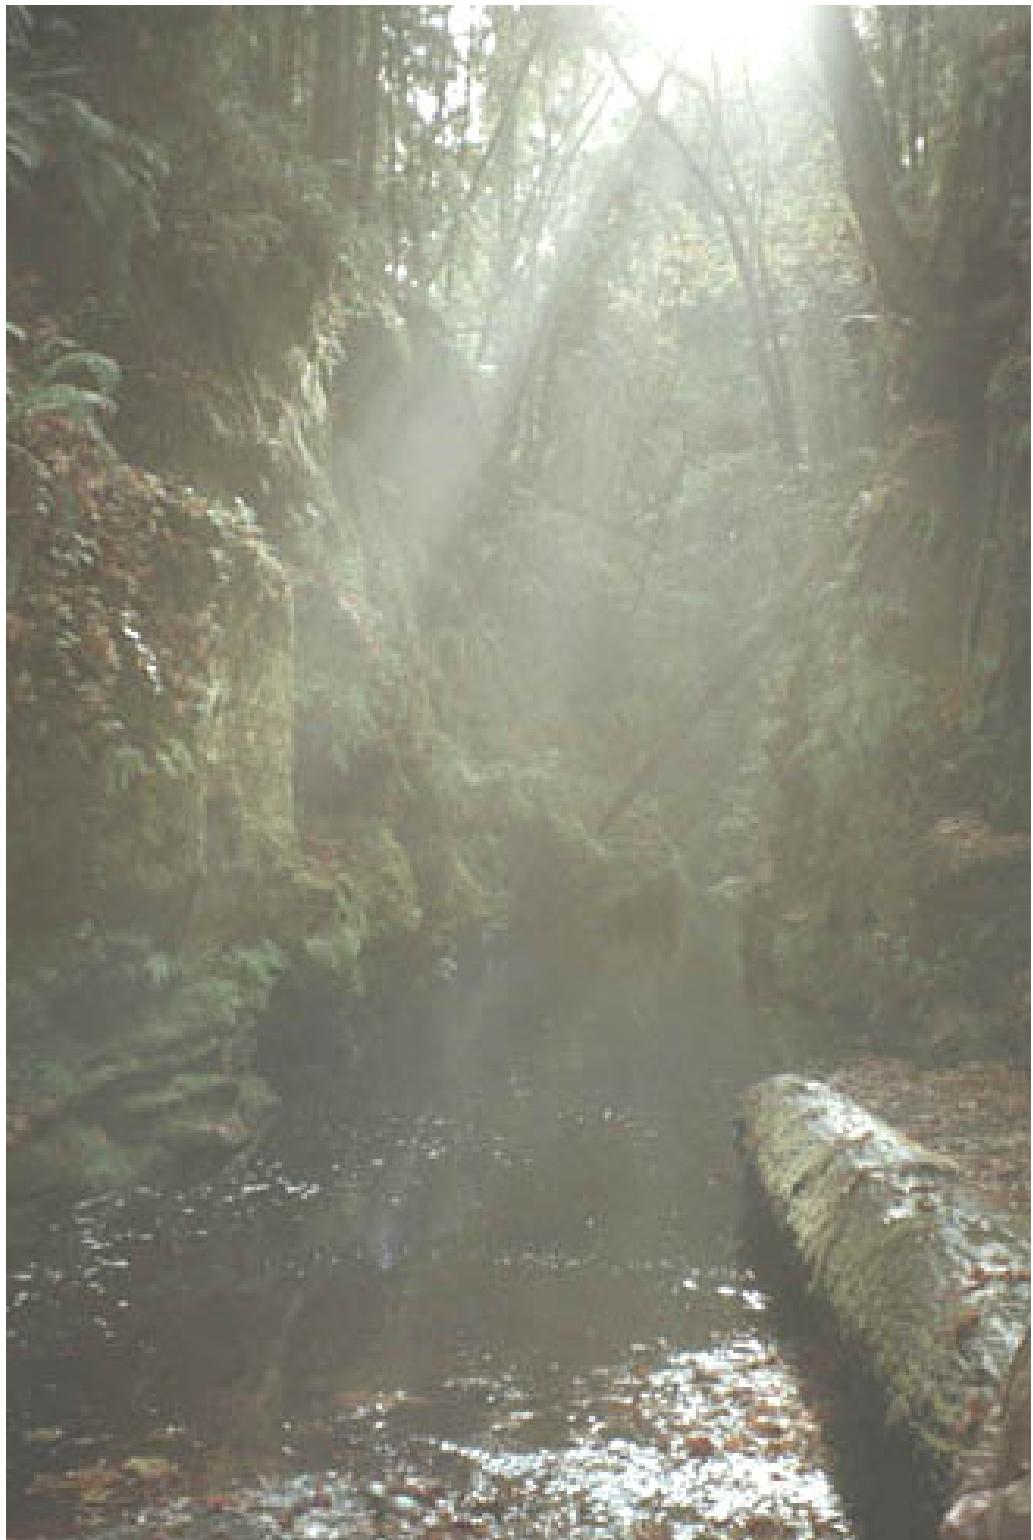
**Figure 3. Typical bedrock pool in Aptos Creek, reach 3**

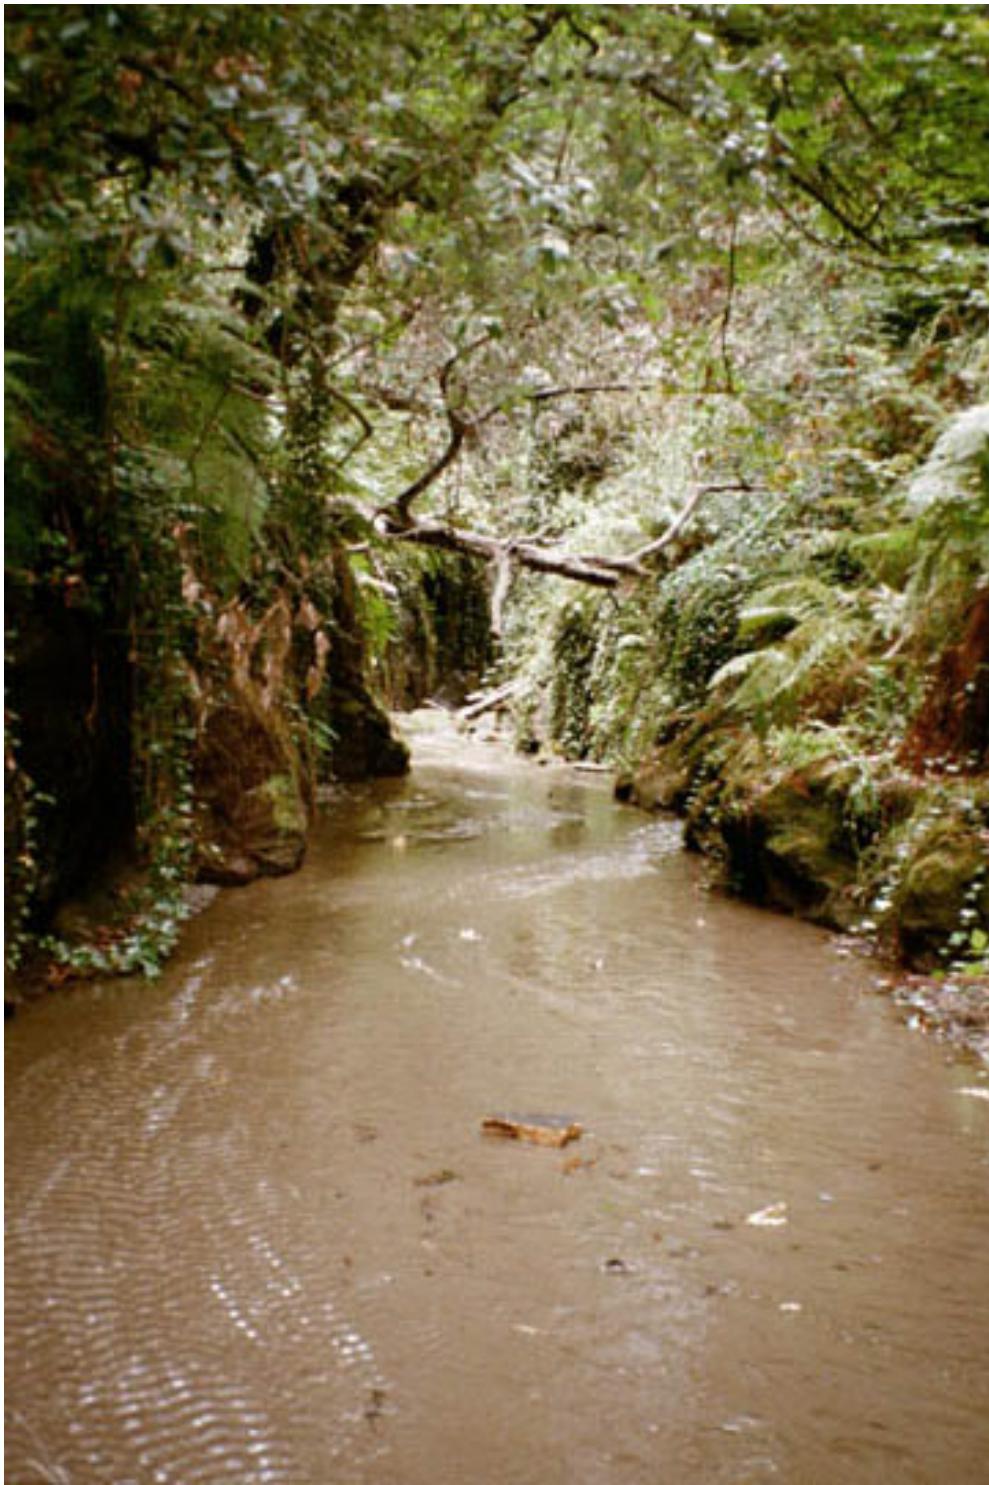
**Figure 12. Riffle/Glide Habitat in Valencia Creek**

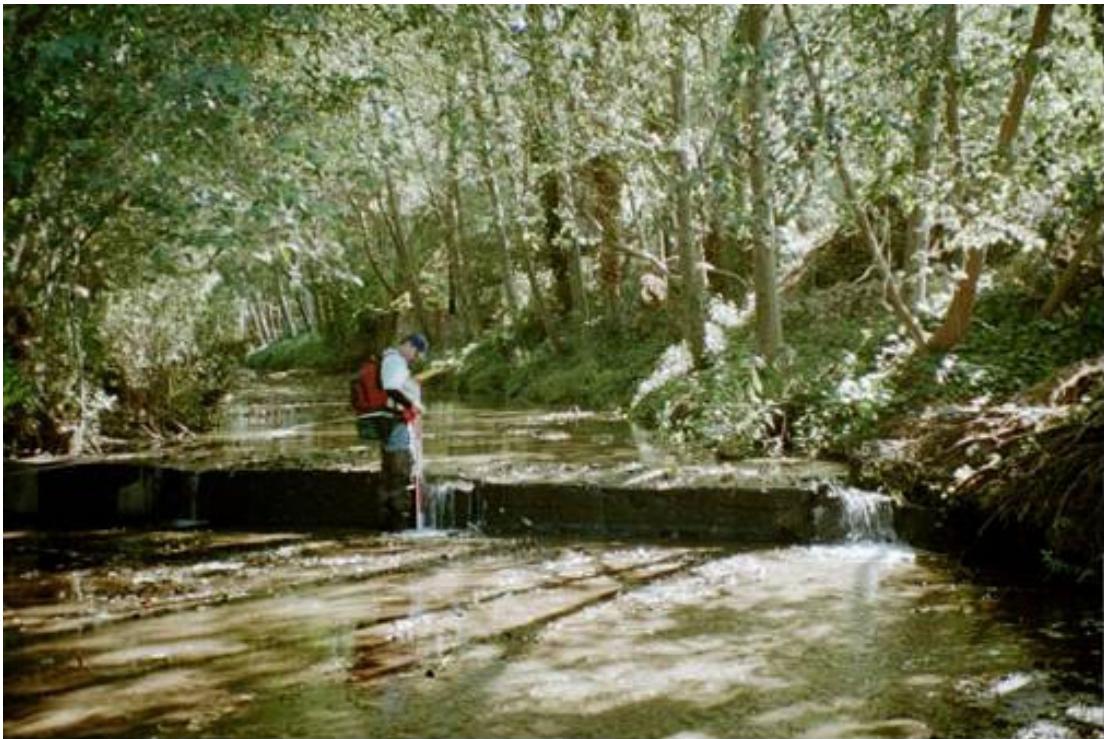
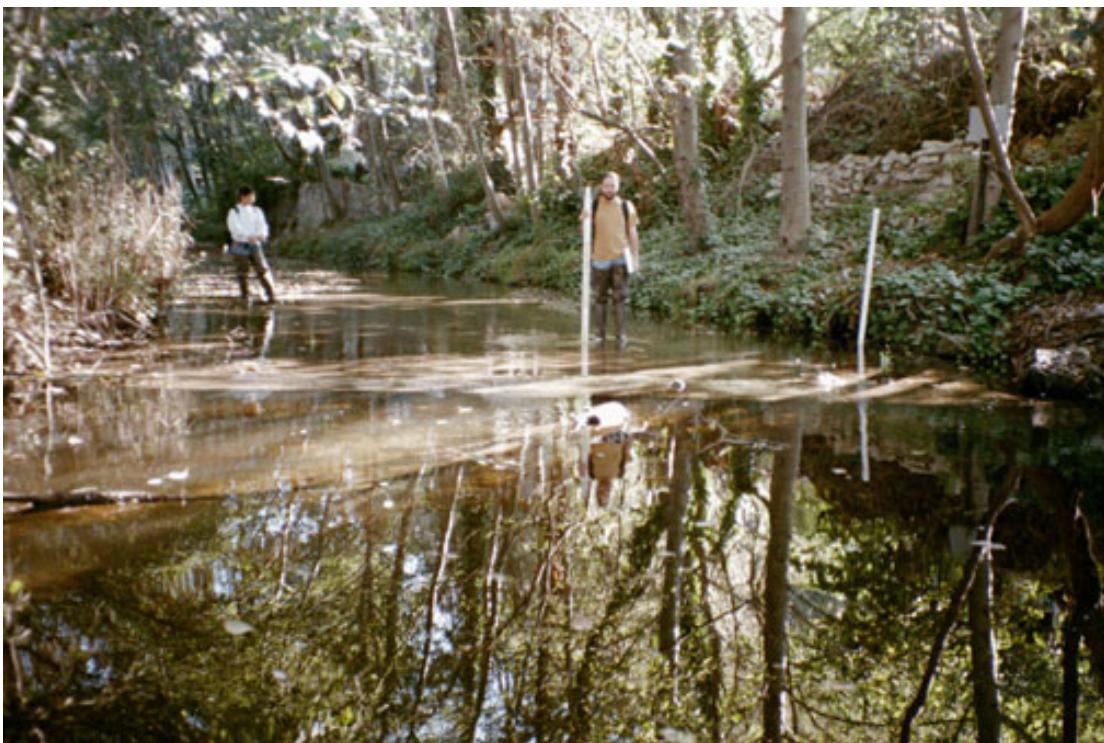
**Figure 16. Weir at Spreckels Road**

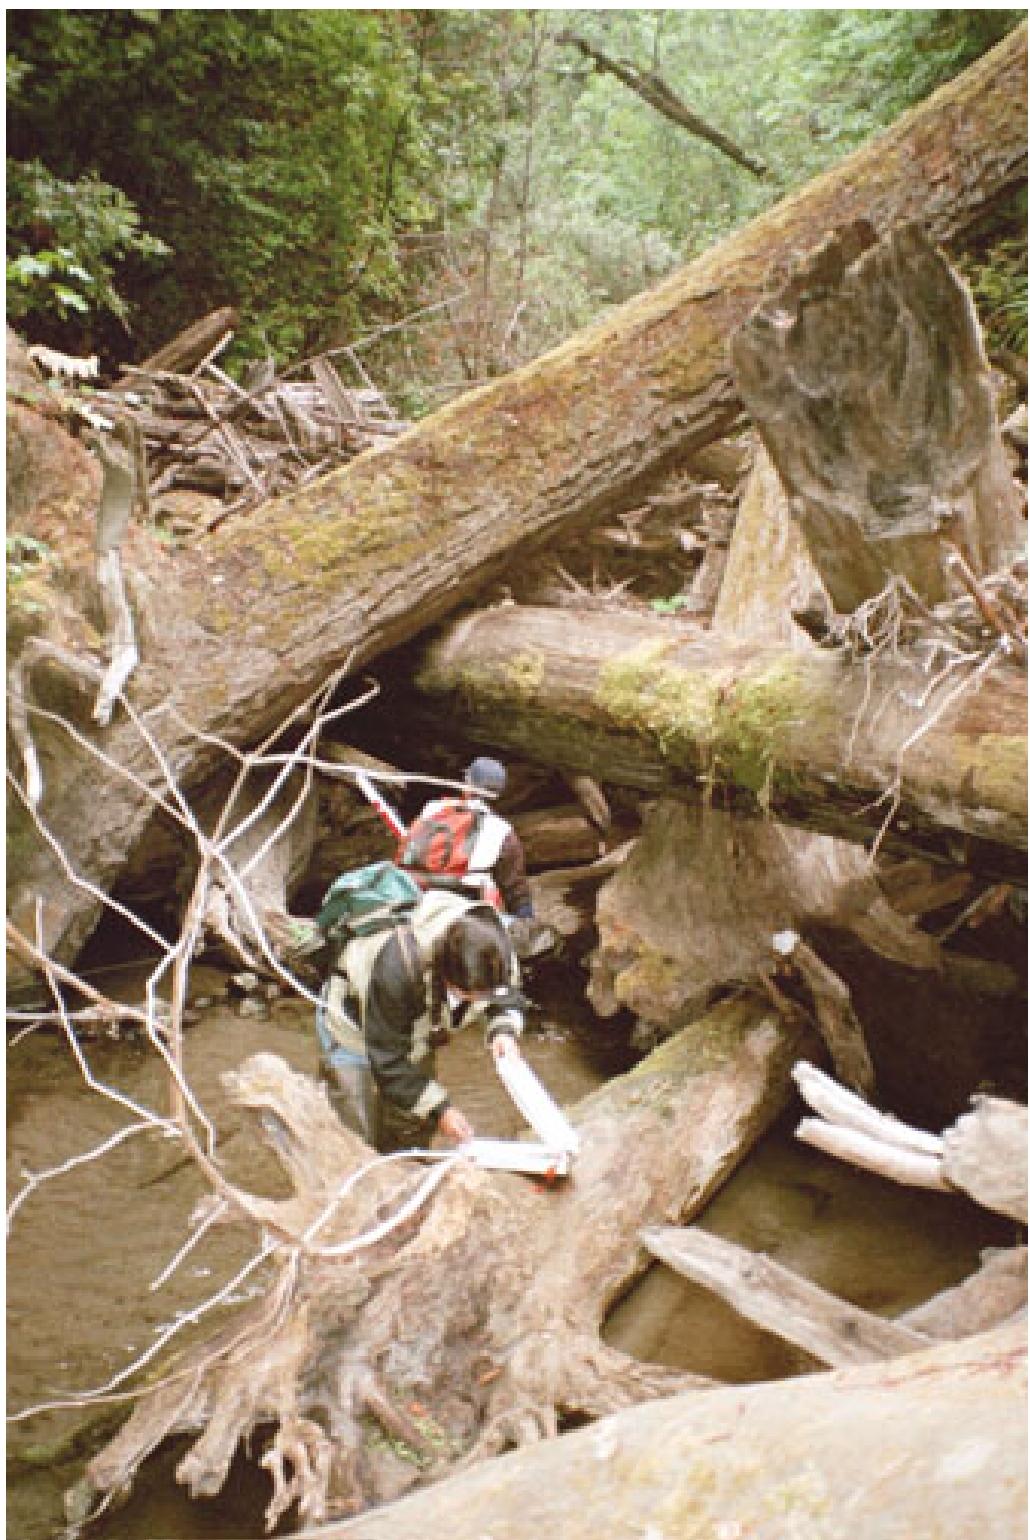
**Figure 17. Large Debris Accumulation (LDA), Upper Aptos Creek**

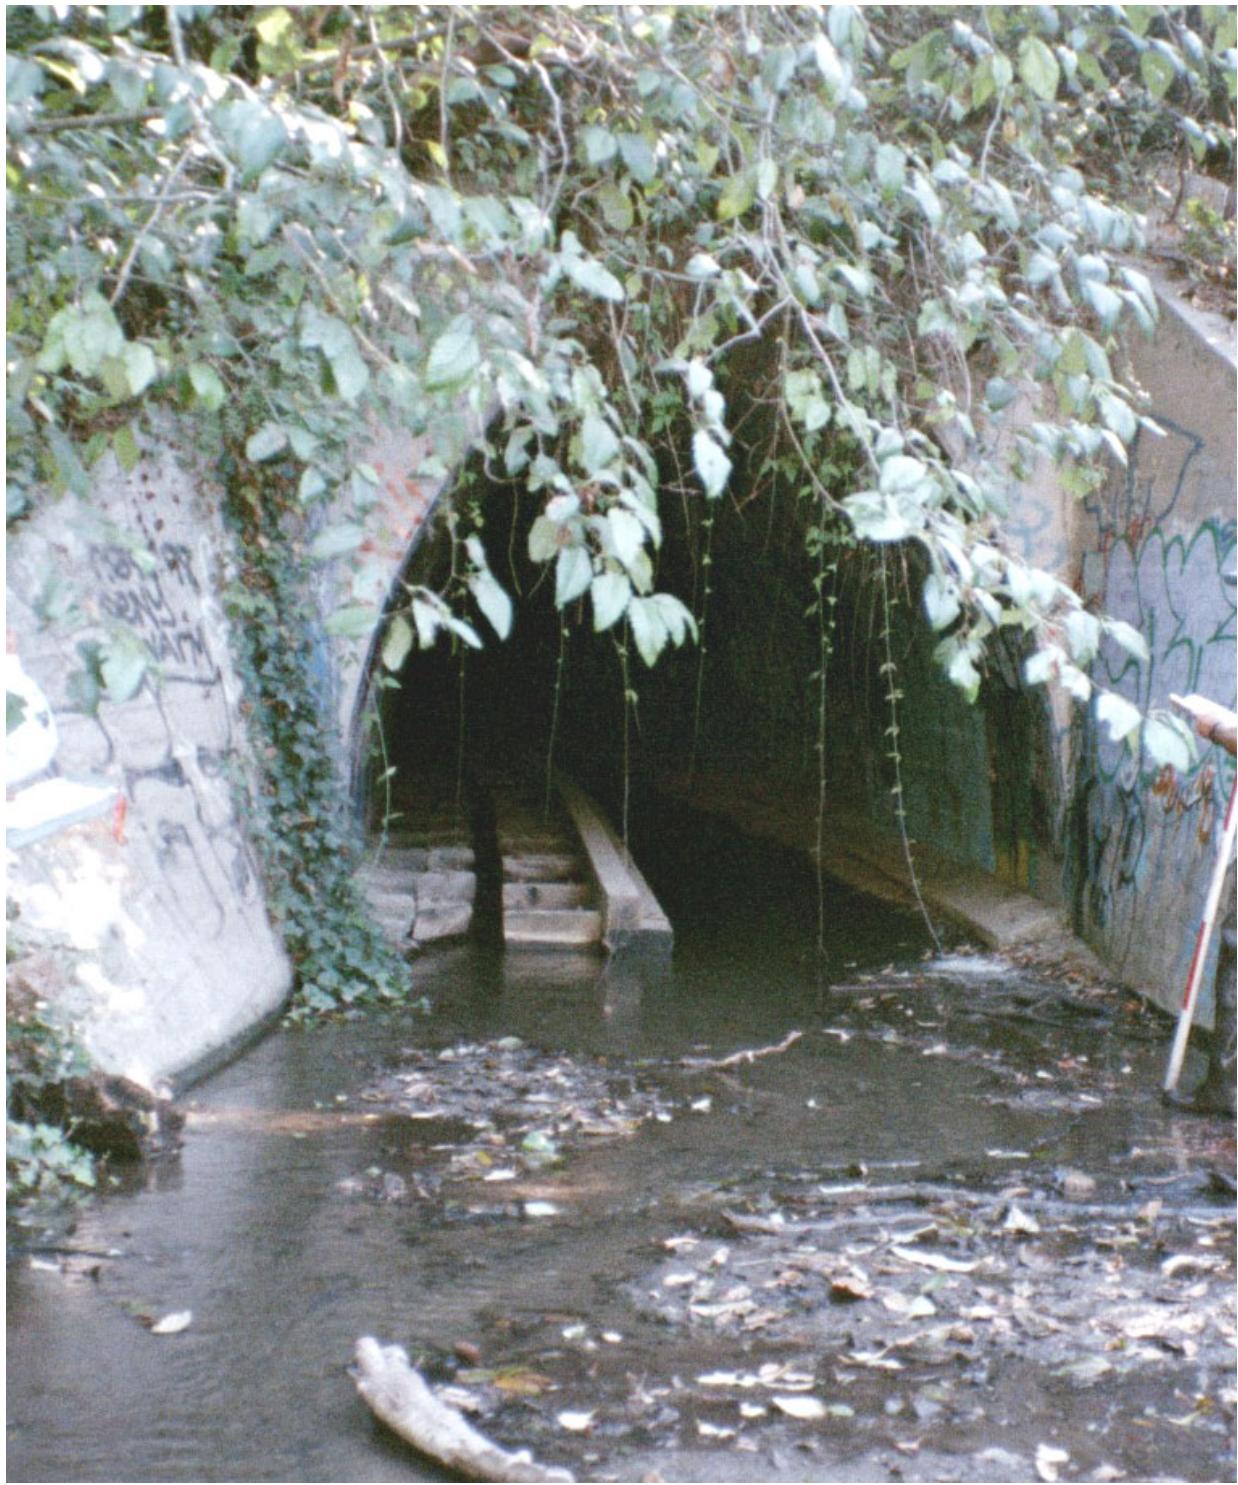
**Figure 19. First Valencia Creek culvert**

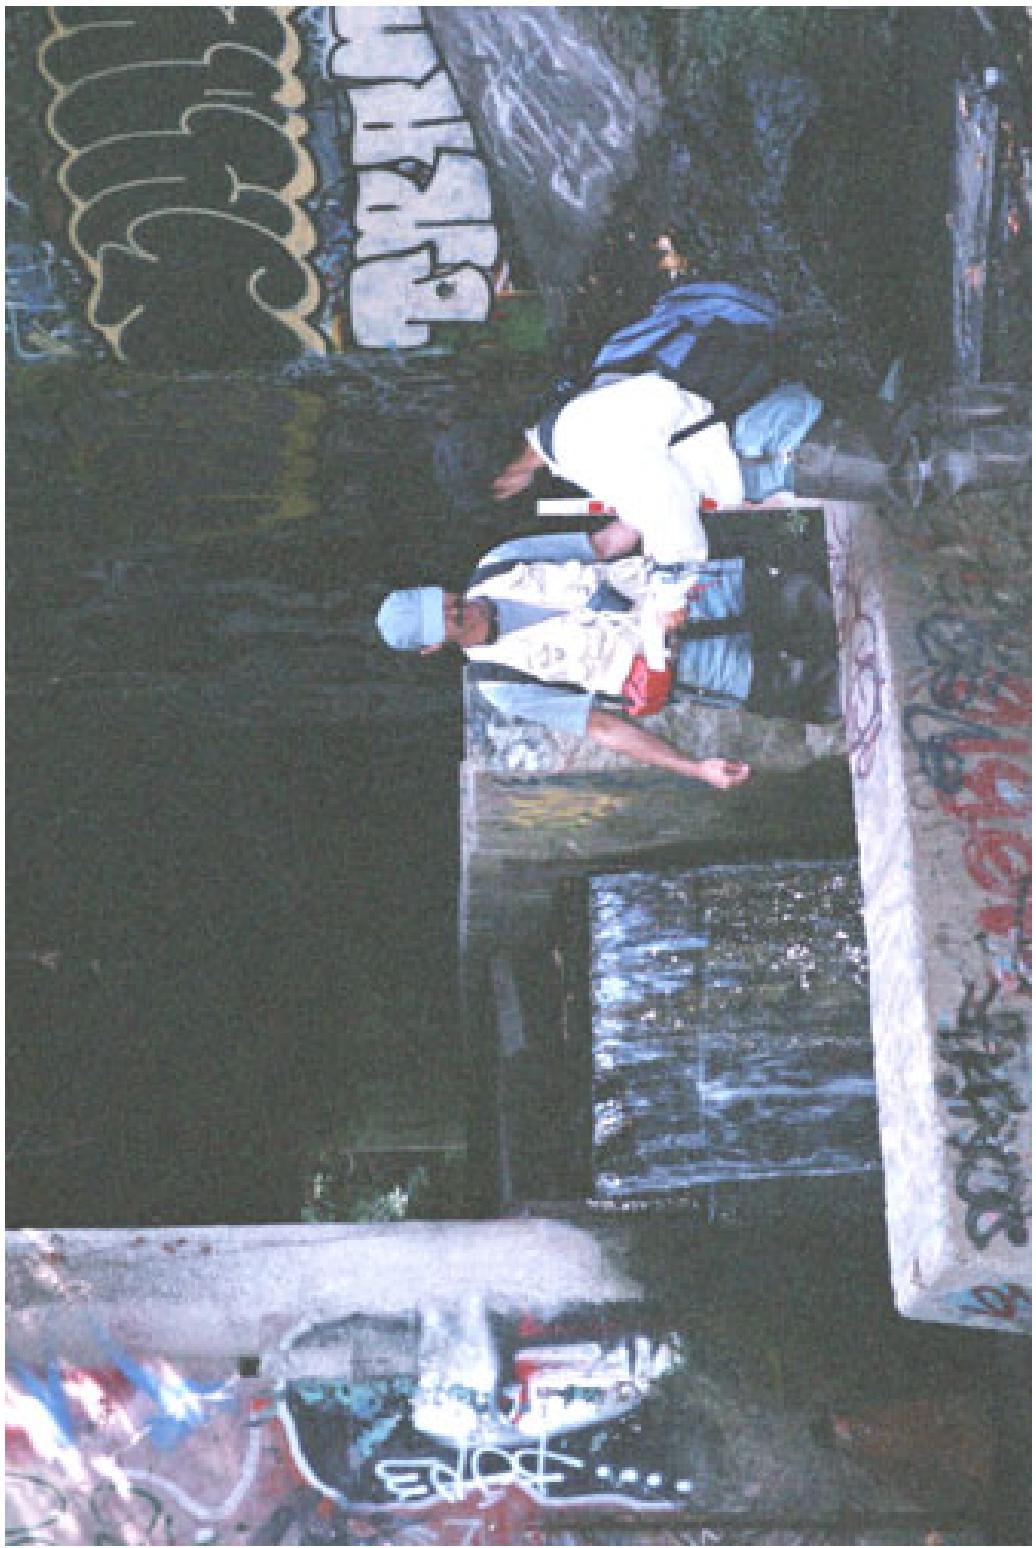
**Figure 20. Third Valencia Creek culvert**

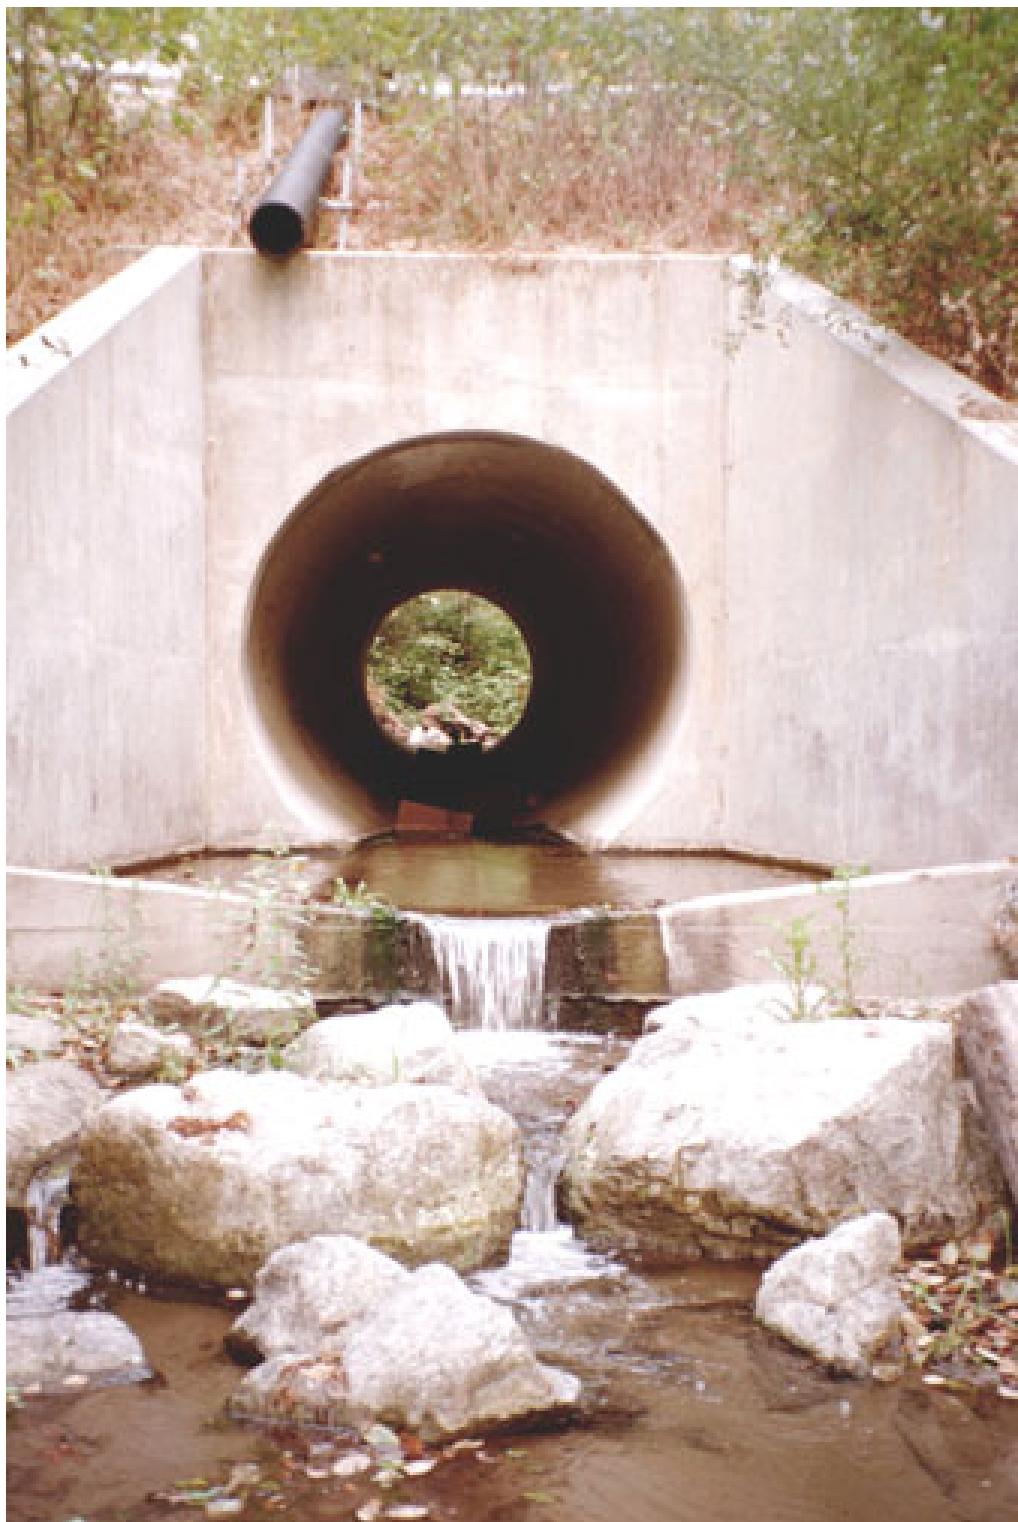
**Figure 21. Fourth Valencia Creek culvert, at Valencia Road**
